FINAL REPORT
RICHARDSON FLATS TAILINGS
SUMMIT COUNTY, UTAH
TDD #T08-9204-015 and #T08-9210-050
PAN EUT0039SBA and EUT0039SDA

U.S. Environmental Protection Agency
Region VIII
Waste Management Division
Mike Zimmerman, On-Scene Coordinator

Scott Keen
Ecology and Environment, Inc.
Technical Assistance Team

DATE SUBMITTED: February 19, 1993

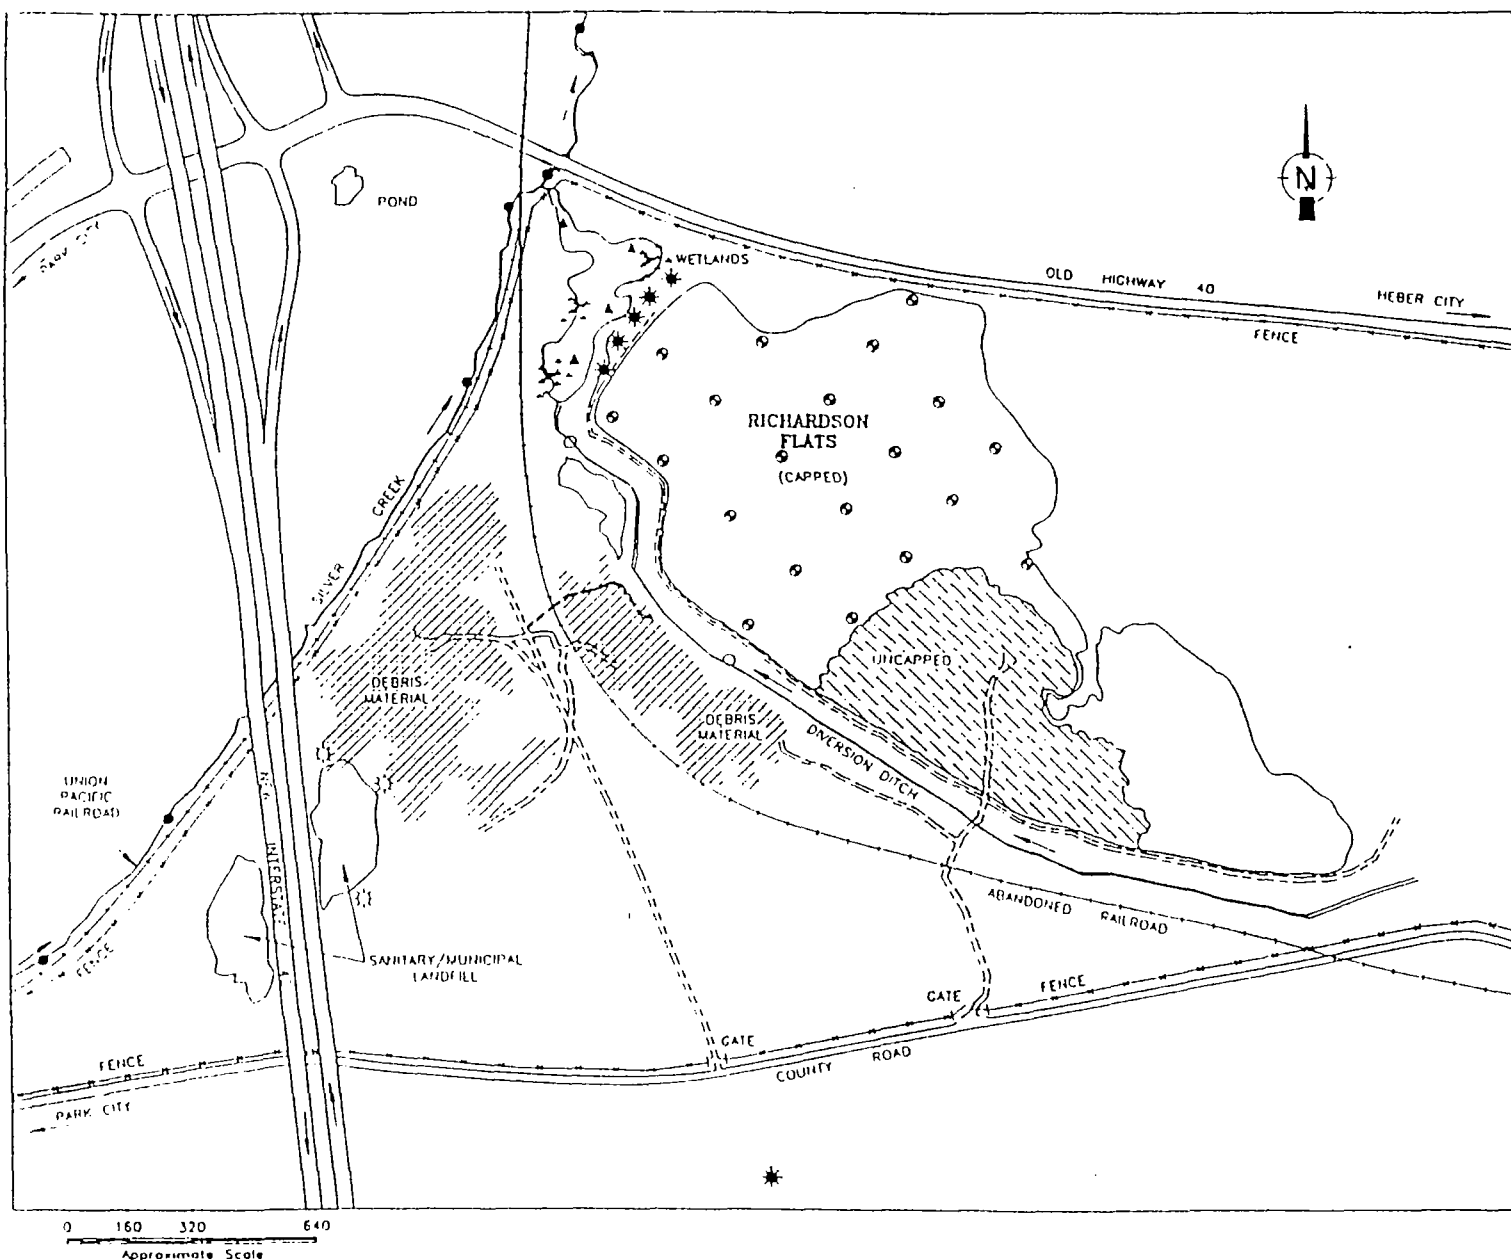
TECHNICAL ASSISTANCE TEAM FOR EMERGENCY RESPONSE, REMOVAL AND PREVENTION EPA CONTRACT 68-WO-0037	
TITLE: RICHARDSON FLATS Park City, Utah SAMPLE LOCATION MAP T.O.D. 108-9204-115	
ecology & environment, inc. DENVER, COLORADO	FIG. 2
Date: 05/92 Drawn by: RSM Scale:

Figure 2 shows the location of six soil samples collected on August 6, 1992. Each of these samples, except sample RF-SO-3, was taken from soil that was added by UPCM as cover to the site. Table 2 contains analytical results for these samples and the normal ranges for these elements in soils of the western United States. Sample RF-SO-3 was collected within an area covered by salt grass. As discussed, where salt grass is currently established soil cover has not been added by UPCM. This soil sample is more likely to be representative of tailings material.
